Cape Lookout National Seashore
GASKILL - GUTHRIE HOUSE

HISTORIC STRUCTURE REPORT

2002
Historic Structure Report
Gaskill- Guthrie House
Cape Lookout Village
CAPE LOOKOUT NATIONAL SEASHORE
Harker's Island, NC
LCS#: 272049

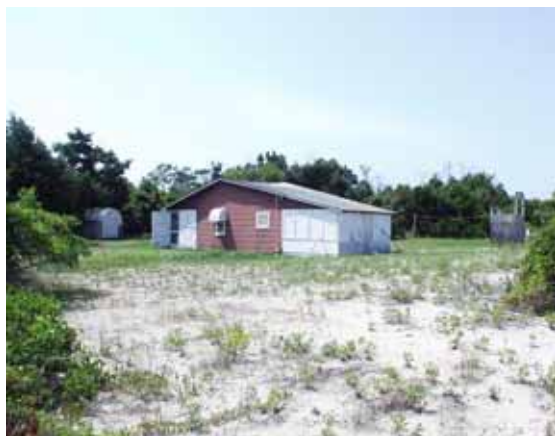
Figure 1 View to south of Gaskill-Guthrie House. Modern metal building is at left, in front of the house; modern shower enclosure is at right, behind the house. (NPS-SERO-CRS,2002)

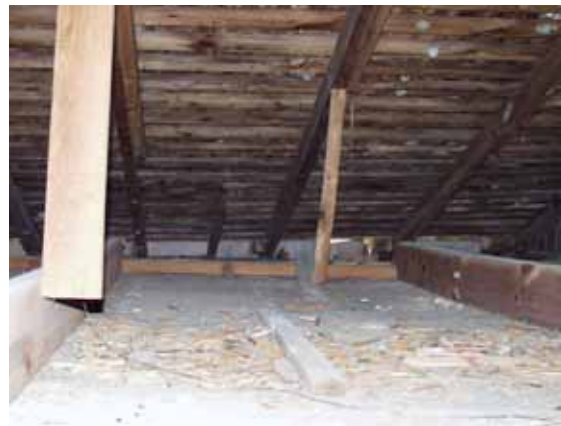
Spacing of joists, studs, and rafters is unusually wide, up to 48" in some cases, and nearly all the framing members are inadequate relative to the demands of modern building codes. An effort was made to storm proof the house, especially in attachment of walls to sills; but overall, the structure is relatively weak and can only have survived 85+ years of coastal storms because of its protected location between the dunes.

Figure 4 View to southeast in attic of original house. (NPS-SERO-CRS, 2002)

- Reduce span of joists and rafters by adding intermediate members.
- Repair termite- damaged and/or rotted sills and other framing elements as necessary.
- Reconstruct original porches.
- Restore original roof line.

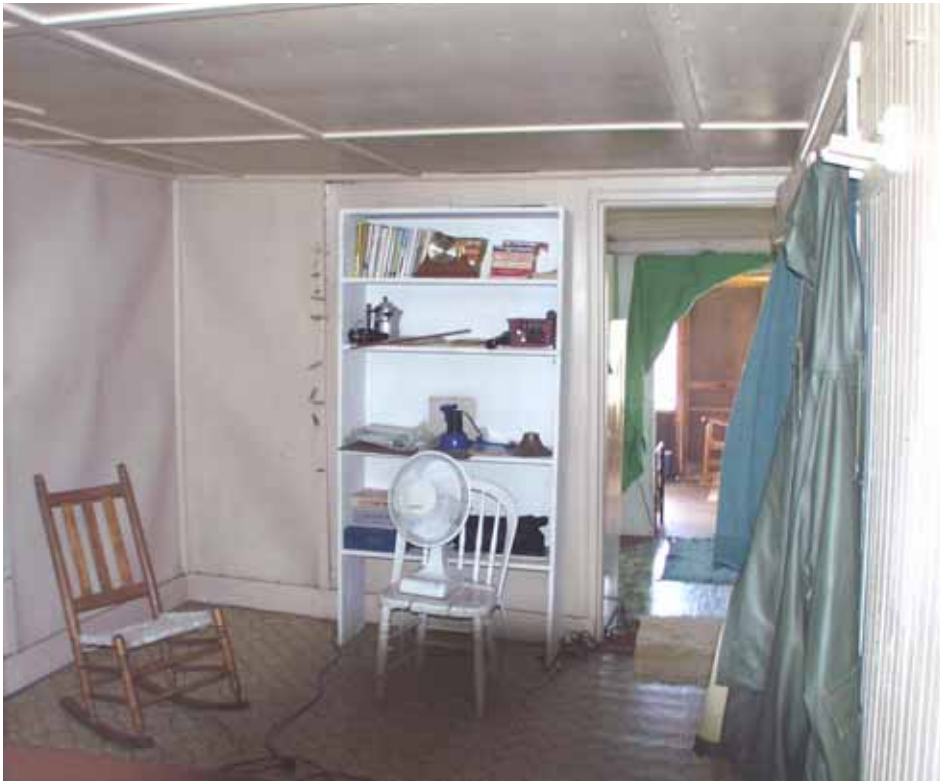
Figure 8 View to west in living room, showing doorway to kitchen. (NPS-SERO-CRS, 2002)

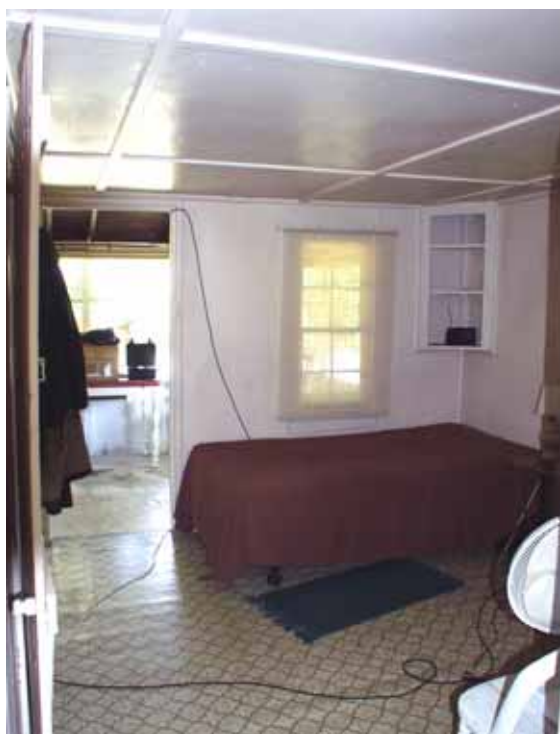
Figure 9 View south in living room, showing door and window to front porch. (NPS-SERO- CRS, 2002)

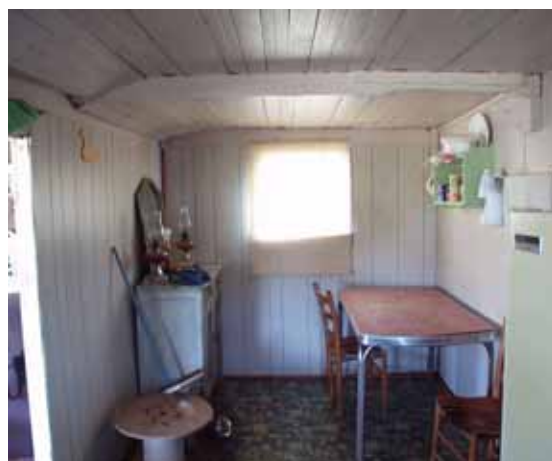
Figure 10 View northeast in kitchen. (NPS-SERO-CRS, 2002)

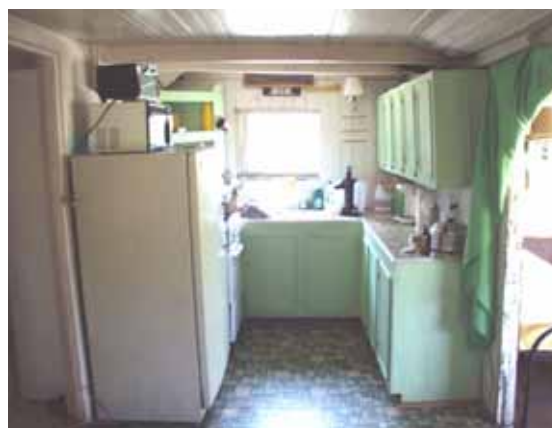
Figure 11 View southwest in kitchen. (NPS-SERO-CRS, 2002)

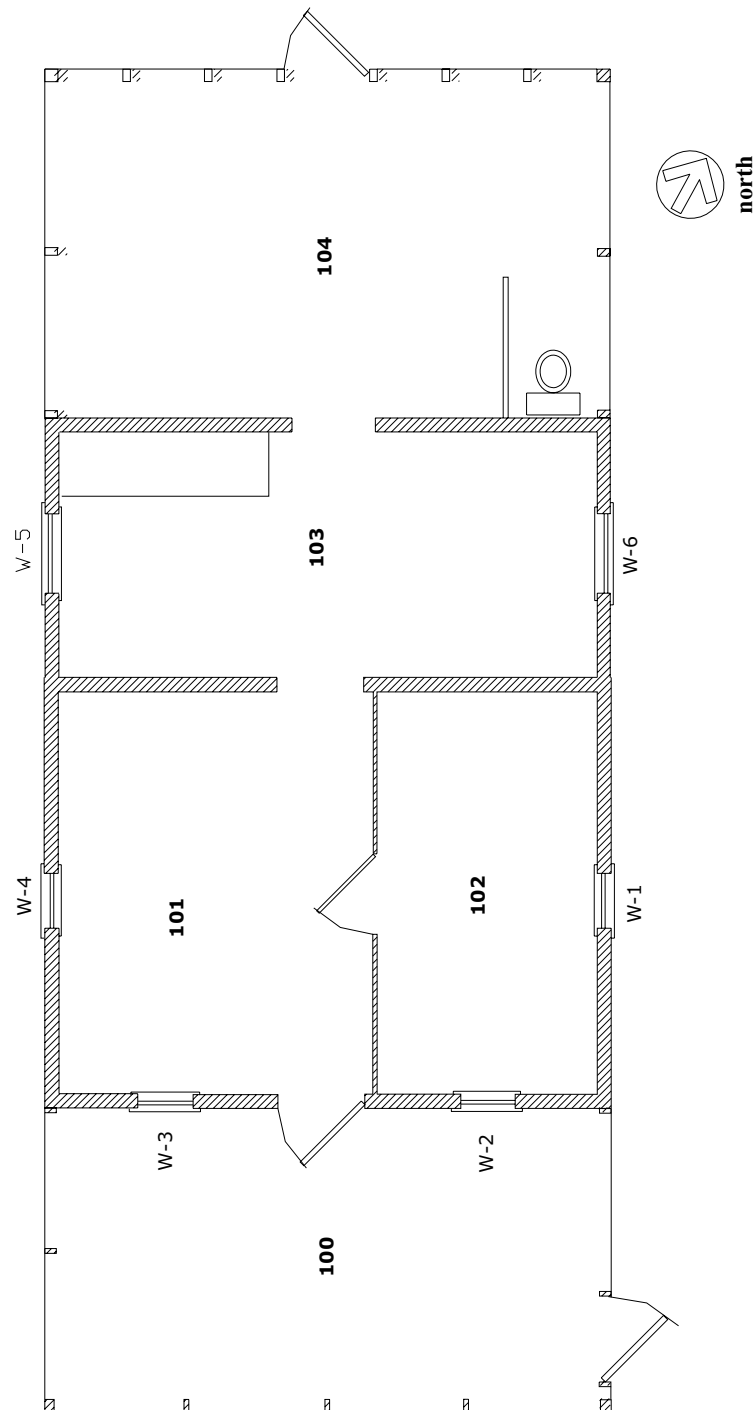
Electricity: The house has been wired for electricity, but the system is haphazardly installed and does not meet modern codes.

Plumbing: Historically, the house did not have an indoor bathroom. A toilet has been added on the back porch since 1976. Off the north corner of the house, a concrete slab, 2'-10" by 3'-3" marks the location of a septic tank, which may only consist of a wooden box or metal barrel buried in the ground and a drain field that appears to be no longer than about eleven feet.

Figure 12 Plan of existing Gaskill-Guthrie House. (NPS-SERO-CRS, 2002)

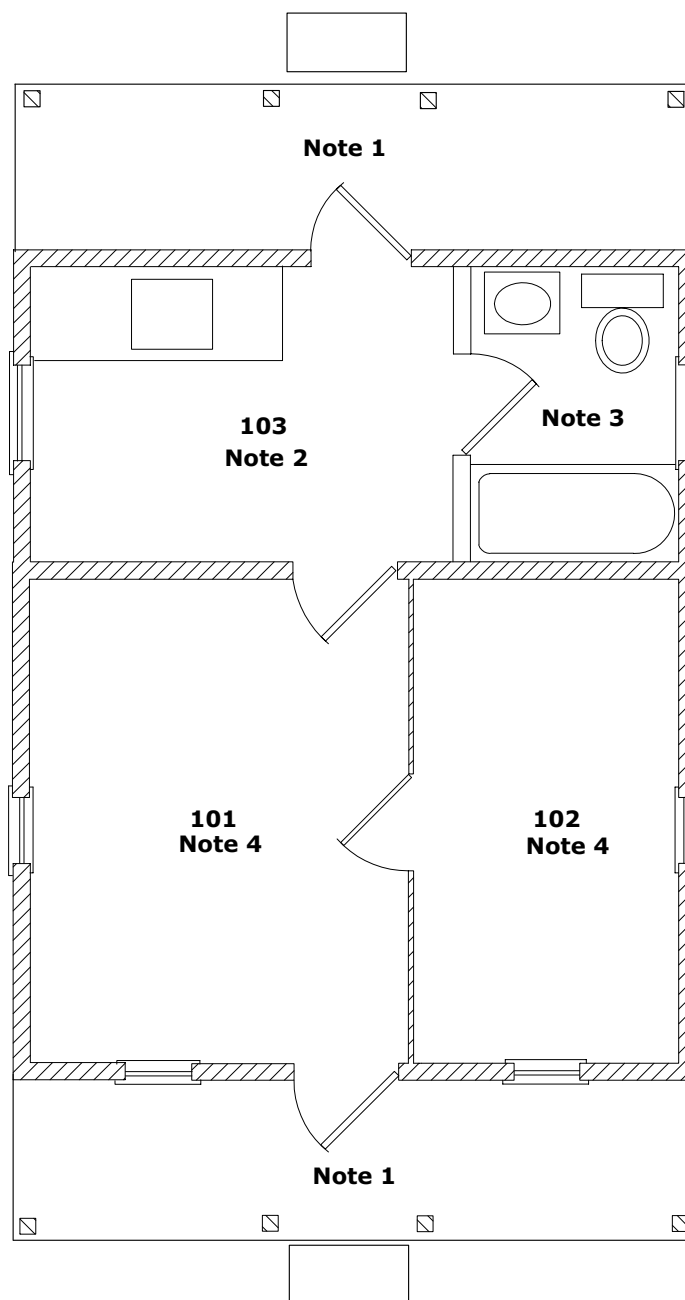
Figure 1 Proposed plan for treatment and use. (T. Jones, NPS-SERO-CR, 2003)

Remove asbestos siding and restore tongue-and-groove siding. Repair existing windows and doors. Install wood-shingled roof.

1. Reconstruct porch using details seen in O'Boyle photographs.
2. Rehabilitate kitchen.
3. Construct partition wall and install new bathroom.
4. Remove hardboard paneling, repair framing, replace hardboard paneling.
